STATE OF CALIFORNIA
DEPARTMENT OF WATER RESOURCES
DIVISION OF RESOURCES PLANNING

BULLETIN NO. 81

INTRUSION OF SALT WATER
INTO GROUND WATER BASINS OF
SOUTHERN ALAMEDA COUNTY

December 1960

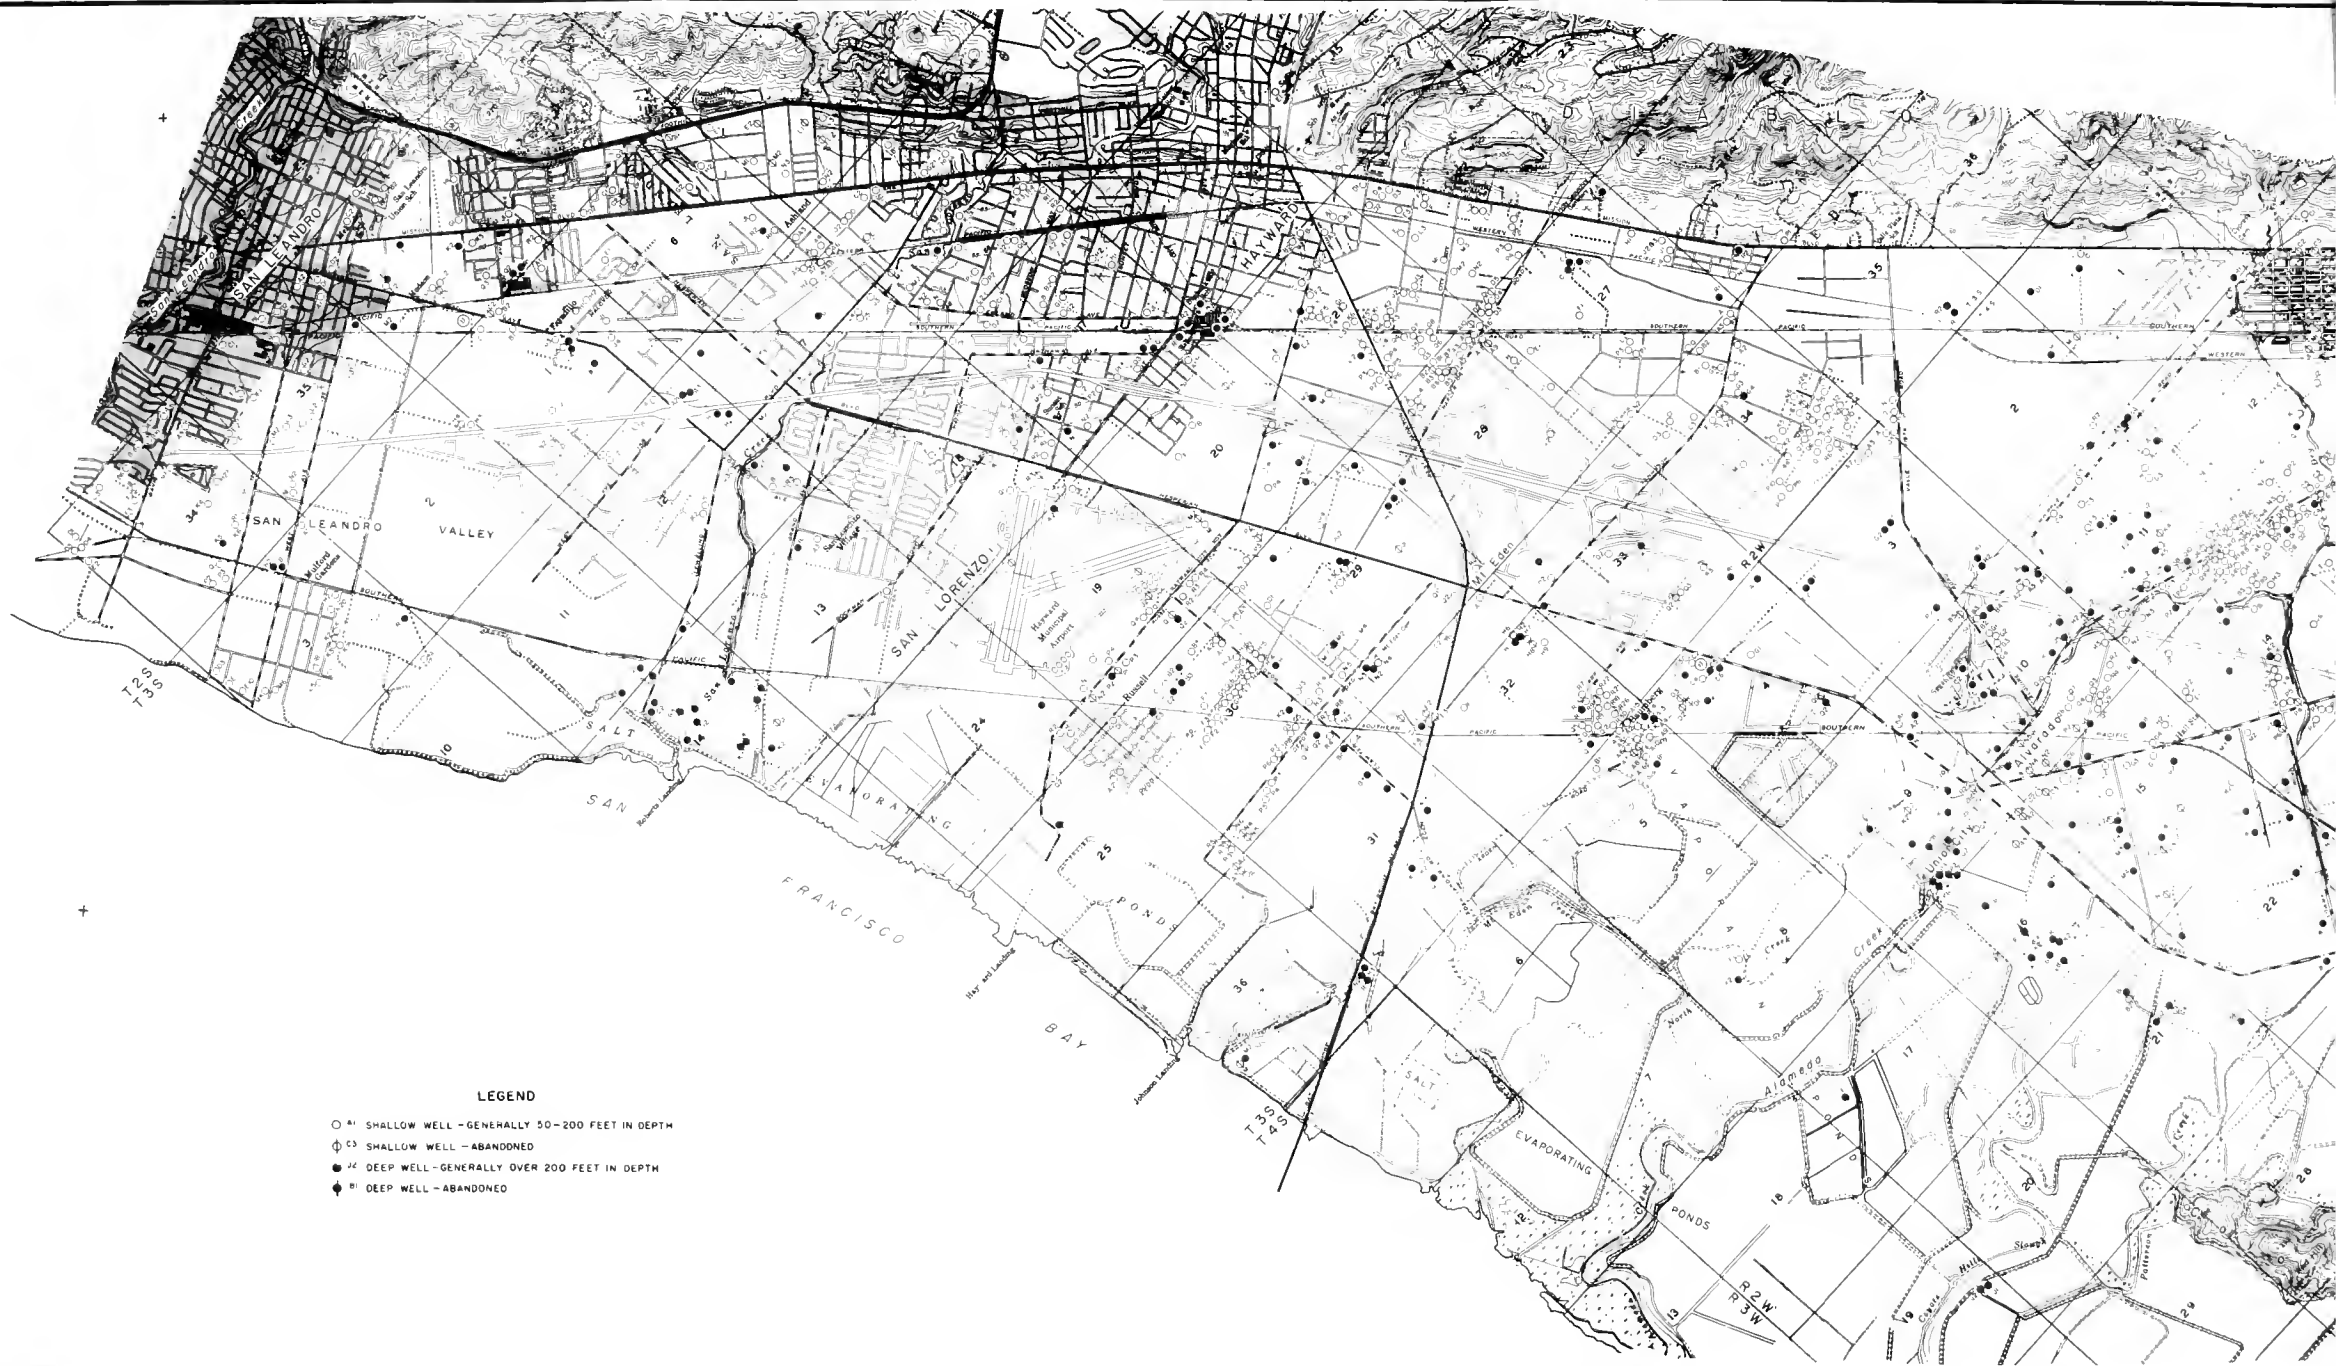
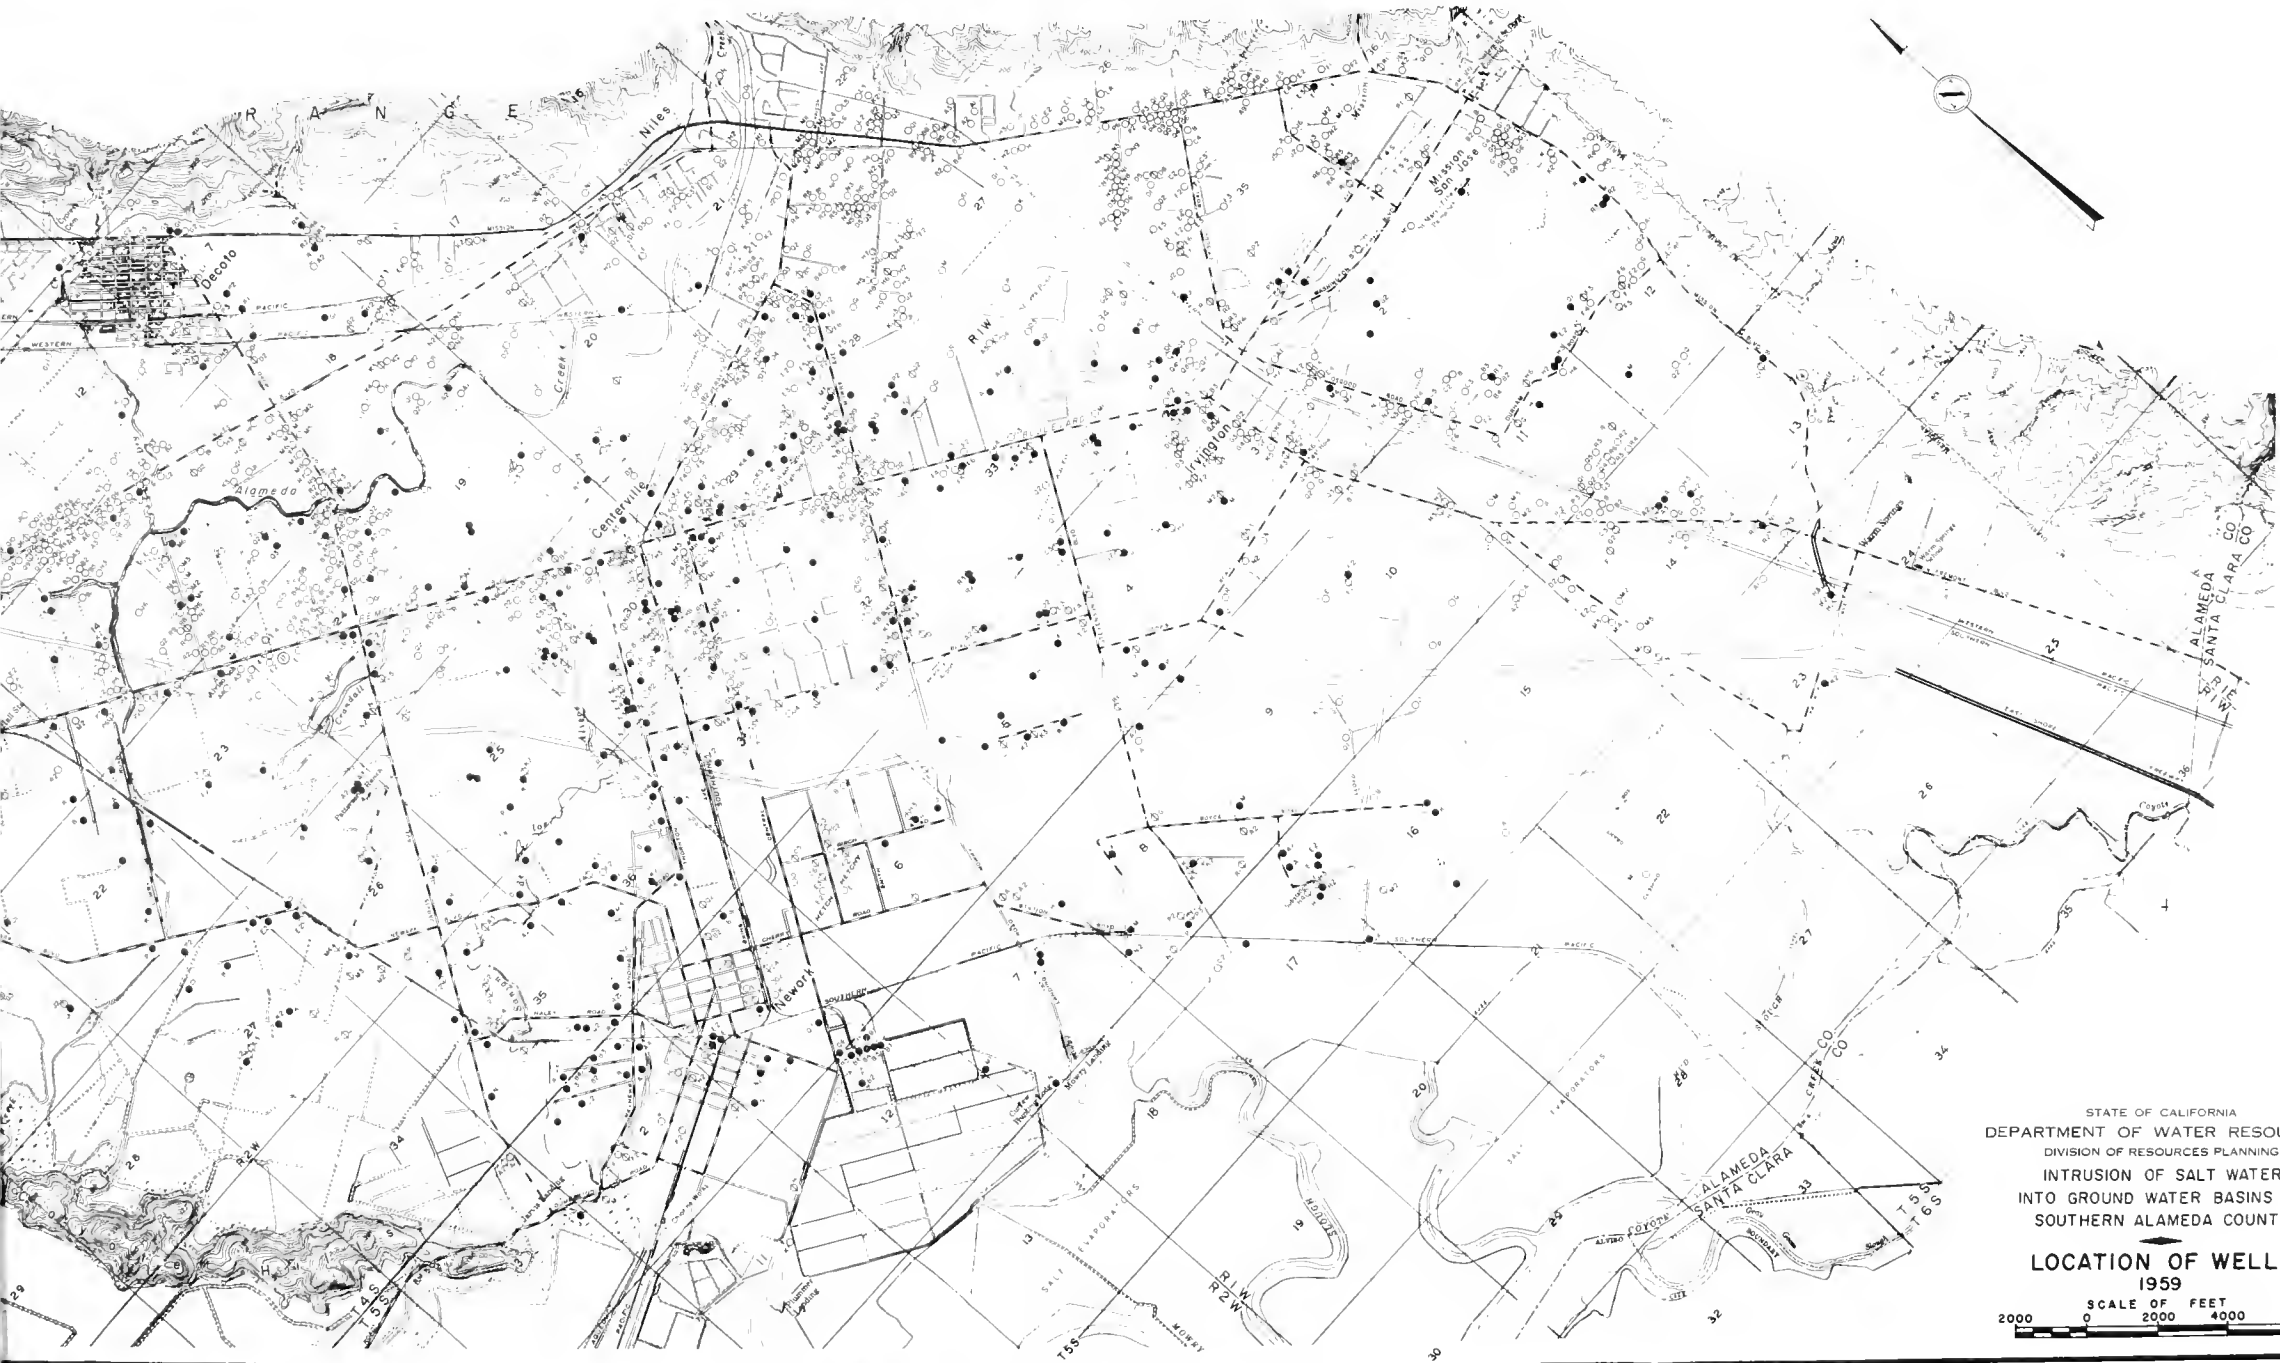
STATE OF CALIFORNIA
 DEPARTMENT OF WATER RESOURCES
 DIVISION OF RESOURCES PLANNING
 INTRUSION OF SALT WATER
 INTO GROUND WATER BASINS OF
 SOUTHERN ALAMEDA COUNTY
LOCATION OF WELLS
 1959

Well locations are shown on Plate 2. Detailed descriptions and locations of wells, a cross-reference of well numbers, wells recommended to be used for water-quality and water-level monitoring, selected drillers' logs, water-level

In the forebay and confined ground-water portions of the Niles cone area (III and IV, Plate 3), it is believed that the locations of most of the deeper wells were established during this investigation, although many of the older, shallow wells could not be found. Well records indicate that there are approximately 360 active wells and 50 abandoned wells penetrating the Centerville and Fremont aquifers in the Niles cone. There are approximately 740 operating wells and 210 abandoned shallow wells (Plate 2).

A comparison of Plates 2, 6, and 7 shows that a relatively small proportion of the abandoned deep wells in the Niles cone area were considered possible problem wells at the time of the field investigation. Continued surveillance and corrective action are, therefore, required to prevent further degradation of water in the deeper aquifers.
